Inspection Report

731 Belmont Ave E., Seattle, WA 98102

Lasswell Home Inspection LLC

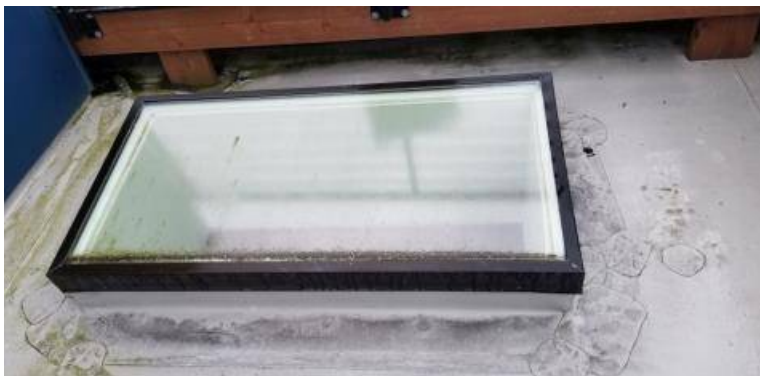
Skylights:

The skylight does not have sufficient slope. The manufacturer of this skylight recommends a minimum slope of 2:12 for a glass skylight. The skylight as installed has a 1.5:12 slope. Without sufficient slope the skylight will not be able to adequately shed water which may cause leaks. I recommend replacing the existing skylight with one designed for low slope application or modifying the skylight curb so the skylight has adequate slope.

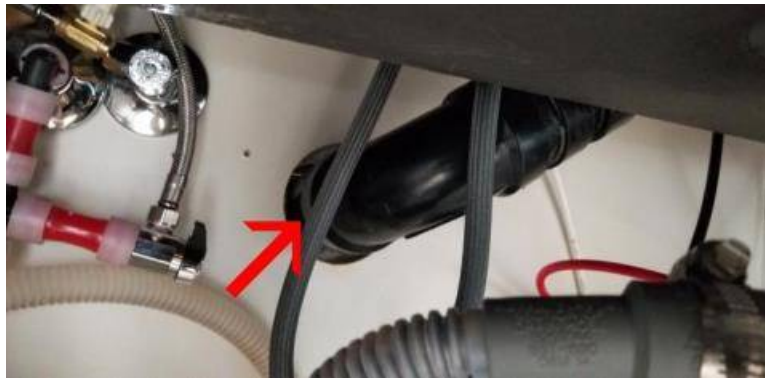
Sink

The hose for the faucet head hits the vent for the drain preventing the hose from extending and retracting properly.

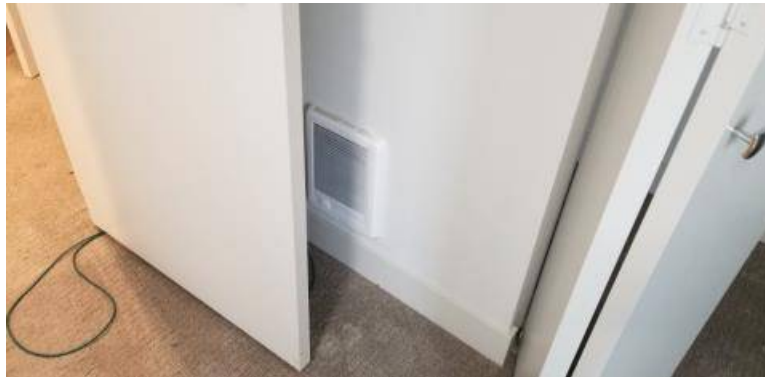
Primary Unit:

Wall heaters in the following location(s) are installed behind doors: basement and first floor bedrooms. The installation instruction for this type of heater state that they should not be installed behind a door. I recommend contacting a licensed electrician to re-locate the heater(s).

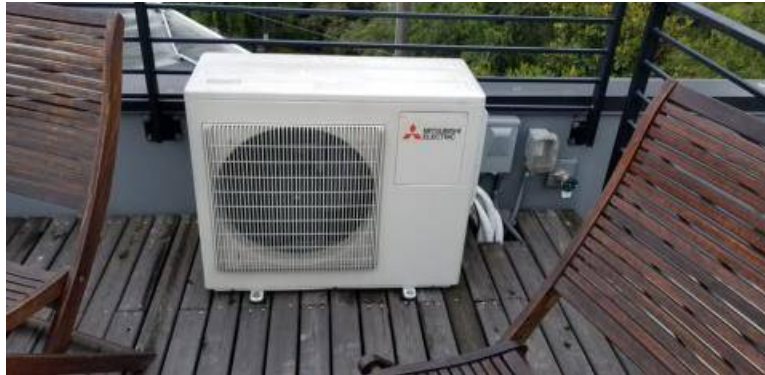
Ductless Heat Pump.

Condition: The heat pump was tested and no visible defects were found.

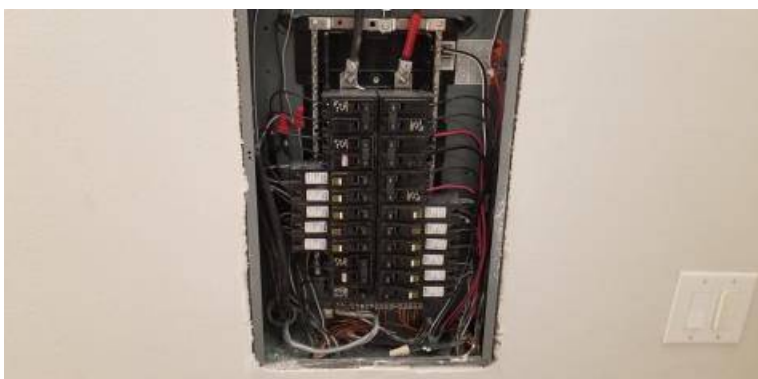
Inspector Notes:

Circuit and wire sizing correct so far as visible. Grounding system is present.

Operation of the AFCI / GFCI breaks was tested. All breakers tripped when the test button was pressed. It is recommended that operation of AFCI / GFCI breakers should be tested monthly.

Service Ground: I was not able to locate a service ground for the panel. The service ground may be located in a portion of the building that is not accessible such as an adjacent unit or electrical room.

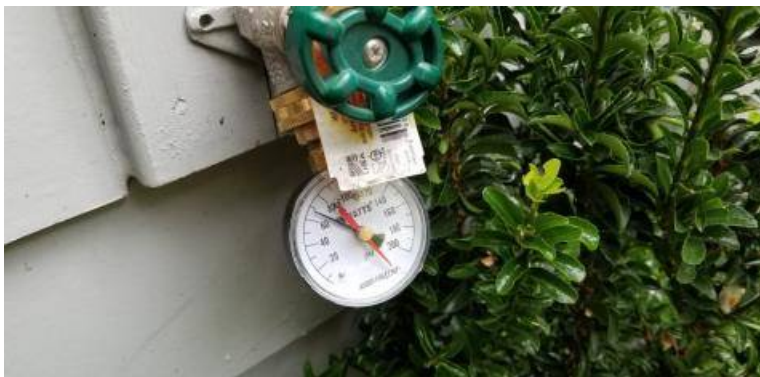
Water Pressure

The water pressure was tested at 65 psi. Normal household water pressure should be between 40 and 80 psi.

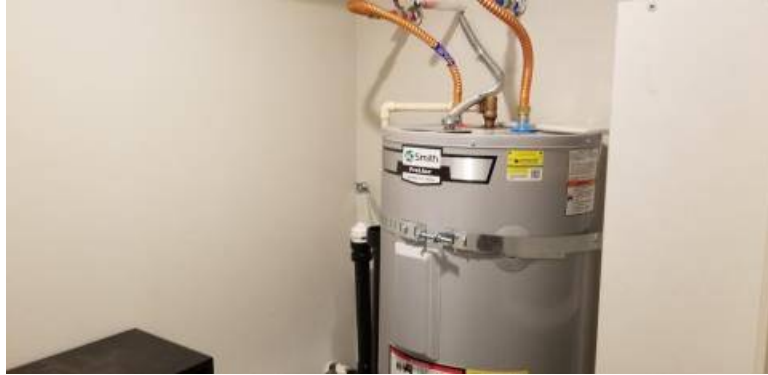
The water heater was manufactured in 2017. Water heaters typically have a life expectancy of 10-15 years. No visible problems were found with the water heater.

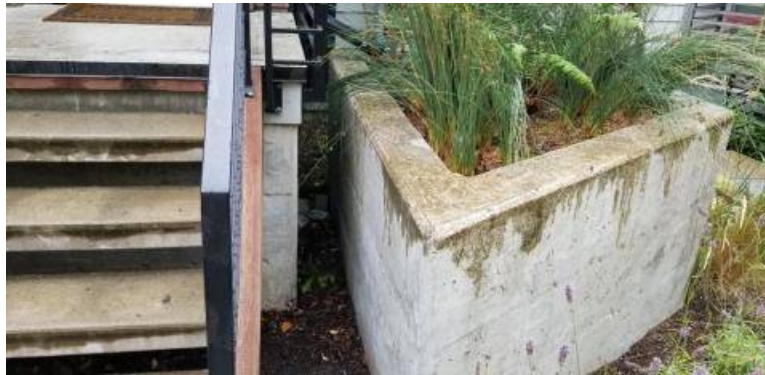
Condition:

No visible defects were found.

I was not able to inspect the area under the porch due to the concrete planter blocking access.
